CASE STUDY: INVESTIGATING A RAIL ROLLOVER DERAILMENT

FRA Track Safety Symposium
St. Louis, MO
April 6, 2022

Brad Kerchof
Advanced Rail Management
Norfolk Southern Railway (retired)

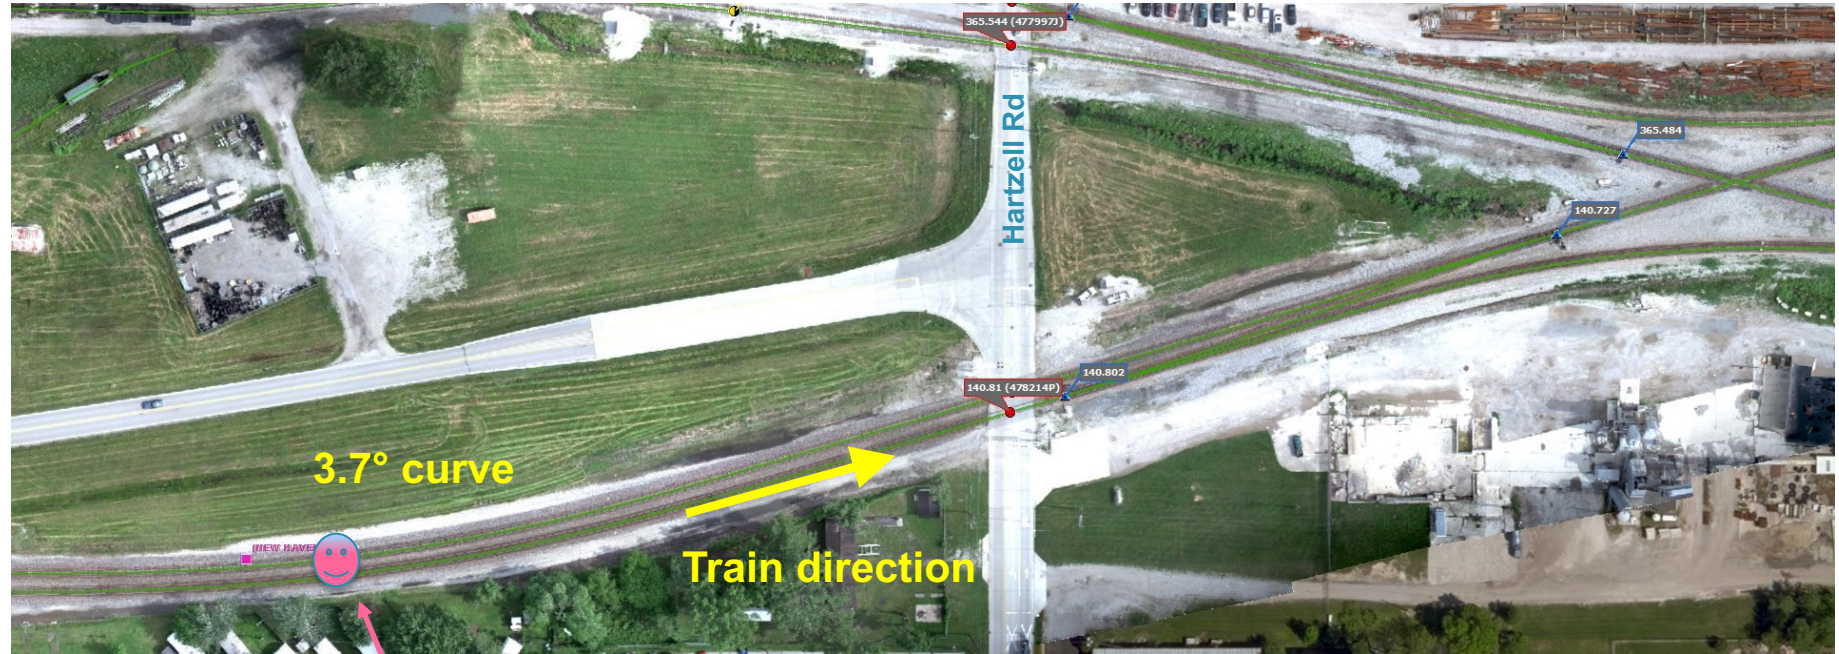
GIS IMAGE OF DERAILMENT SITE

Camera location in slide 2

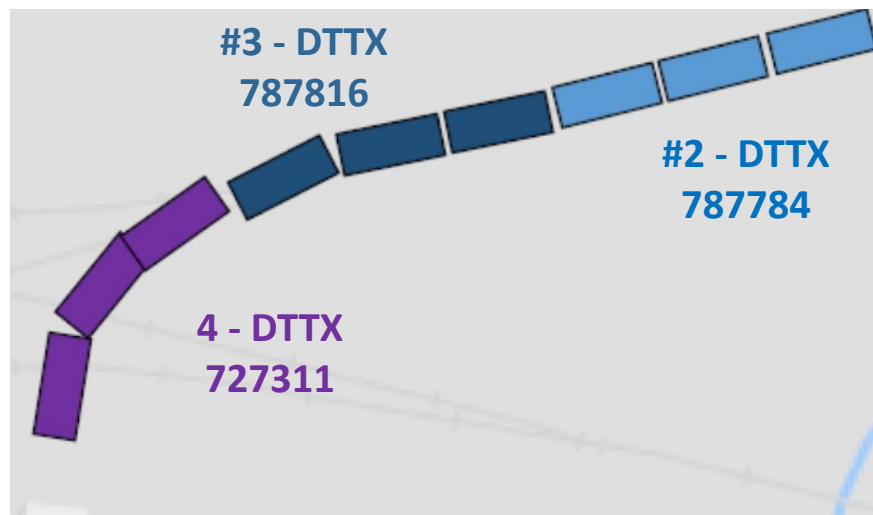
MECHANICAL REVIEW – CAR INSPECTION

2nd head car, **DTTX 787784**, lead truck (the one thought to have derailed and then rerailed itself) inspected in car shop. No exceptions.

3rd head car **DTTX 787816**, trail truck inspected in car shop, wheels replaced due to minor derailment damage. No other exceptions.

4th head car **DTTX 727311**, all four trucks derailed, with severe damage to the wheels under the two intermediate (C and D) trucks. Car was not re-railed. A thorough inspection was not possible.

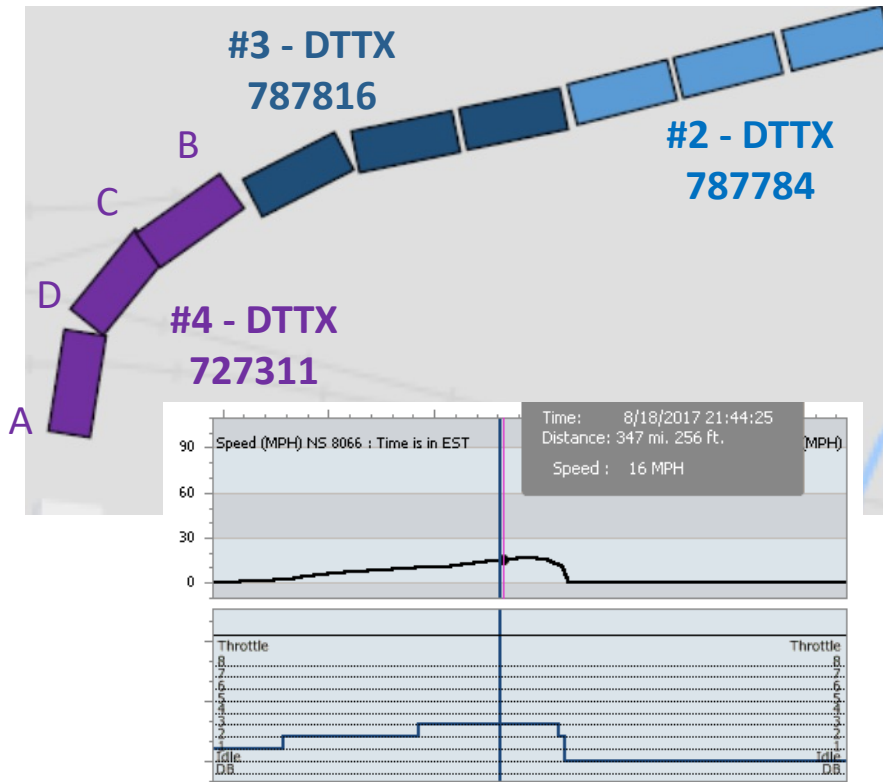
What is a key piece of evidence?

4th head car DTTX 727311, all four trucks derailed, with **severe damage to the wheels under the two intermediate (C and D) trucks.**

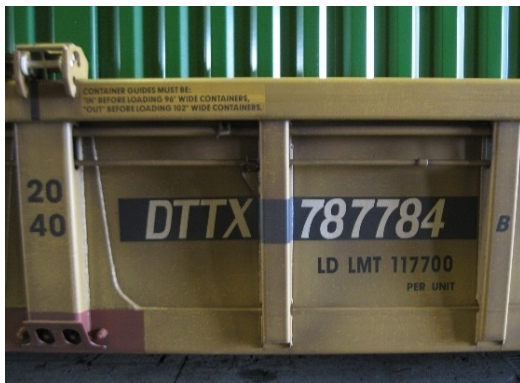
Suspect: 2nd head car, lead truck

- Conclusion: This truck did not derail

R1 showed several white marks on the flange. During a car shop inspection, however, no evidence was found on the tread or flange tip that indicated that the wheel had been on the ground.

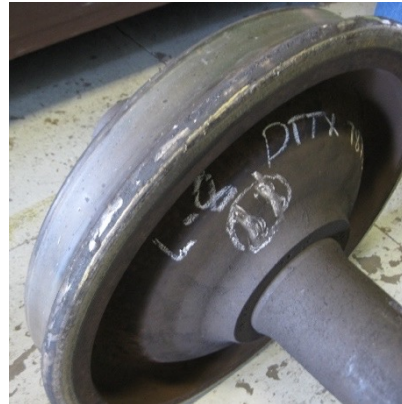
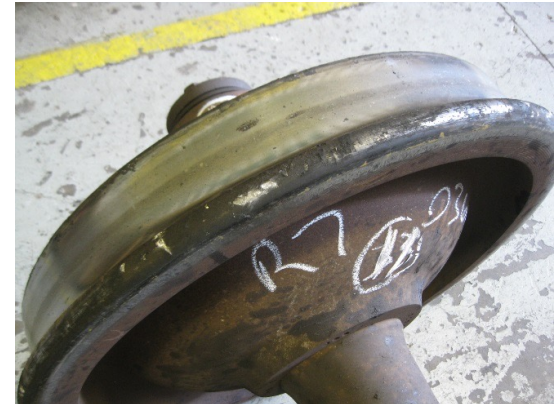
The first derailed wheels were under the trail truck of the 3rd car.

These wheels show some flange contact with the ground, but not enough to have been the first to derail (they would have run over 2 turnouts and a diamond).

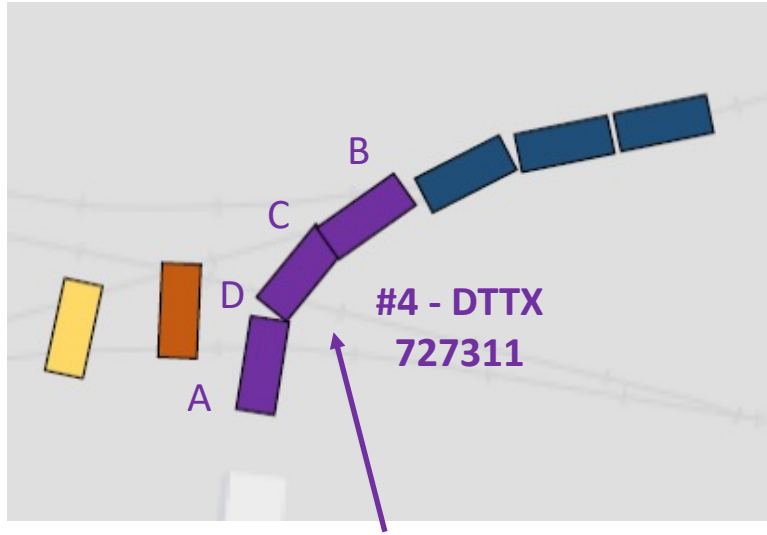
HOW ABOUT THE 2ND DERAILED CAR – DTTX 727311?

Wheels under all
4 trucks derailed

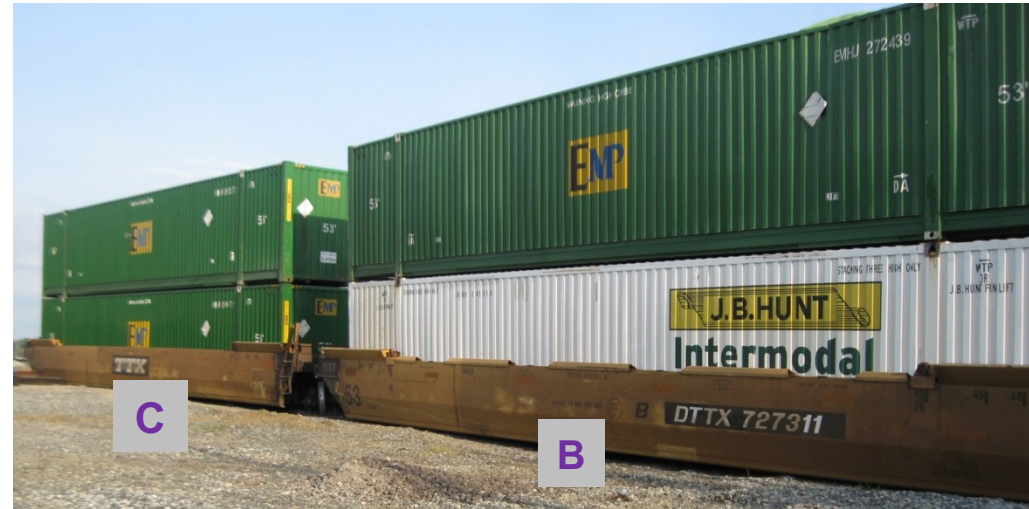
The B (lead) and C platforms are shown below.
Between them is the C truck. The D truck and the
A platform were separated by the derailment.

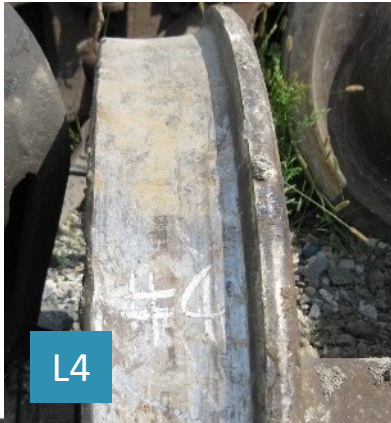
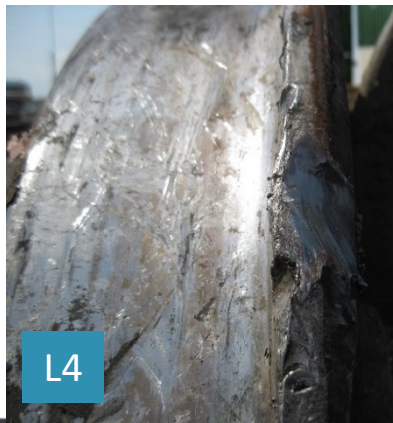
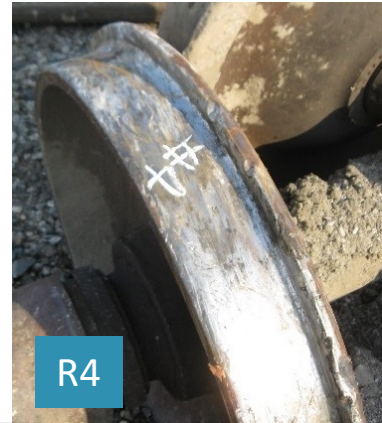
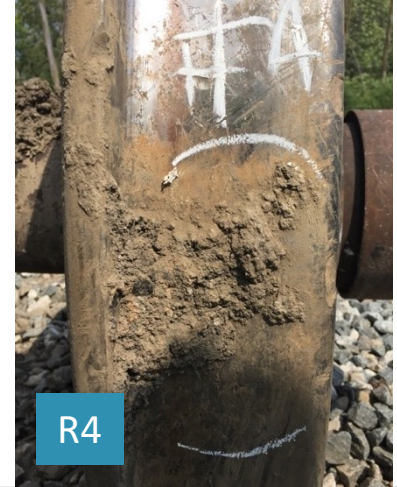
L3 and R3 showed moderate damage.

L4, L4 flange, R4, and R4 tread (with asphalt deposit from Hartzell Rd crossing).

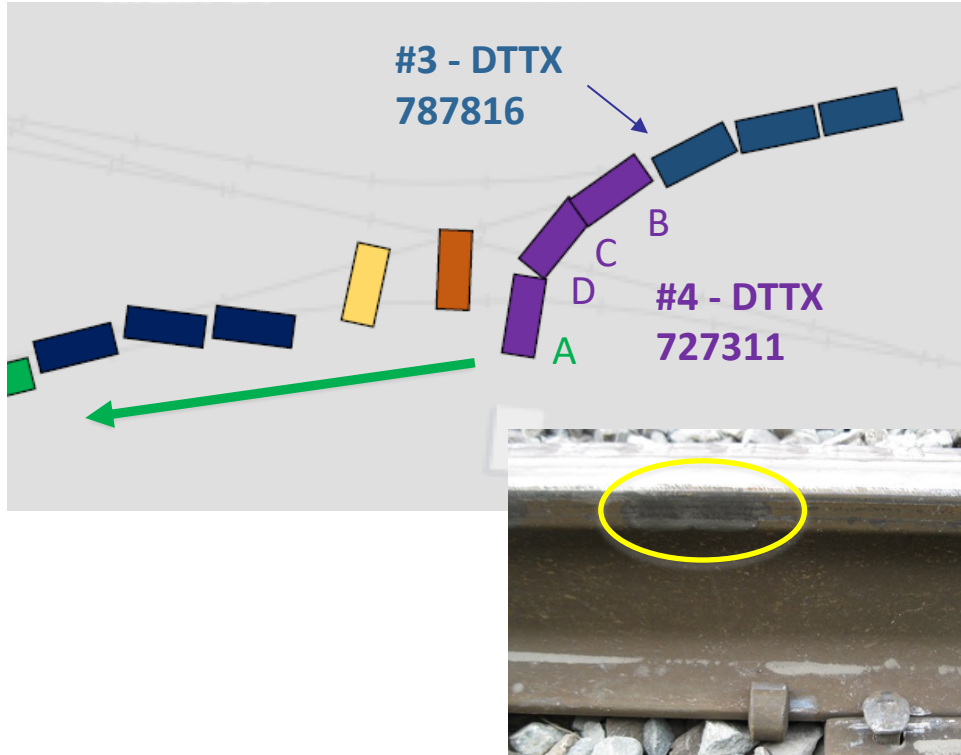
DERAILMENT EXPLANATION (AND ANSWERS TO OUR TWO QUESTIONS)

Based on damage to wheels 3 & 4 (truck C) and 5 & 6 (truck D), we concluded that:

1. Intermediate trucks **C** and **D** under the 4th car **DTTX 727311** were the first to derail, as a result of rolled rail.
2. These derailed trucks subsequently pulled off lead truck **B**, which then pulled off the trail truck of the 3rd car **DTTX 787816**.
3. All following trucks derailed due to the rolled rail.
4. The POD was identified at the first drop-in mark on the low-rail.

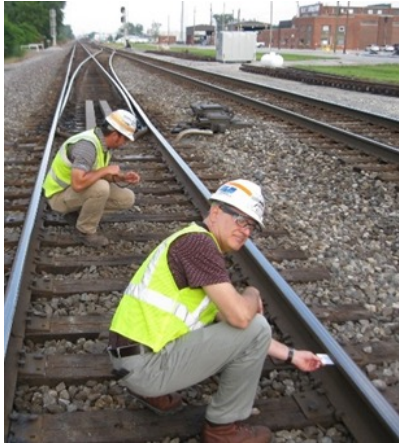
Entrance to curve, 350 ft. before POD

The low rail gage face showed evidence of wheel flange contact from the beginning of the curve to the POD.

In order for wheel flanges to contact the gage face of a low rail, the rail must be canted out!

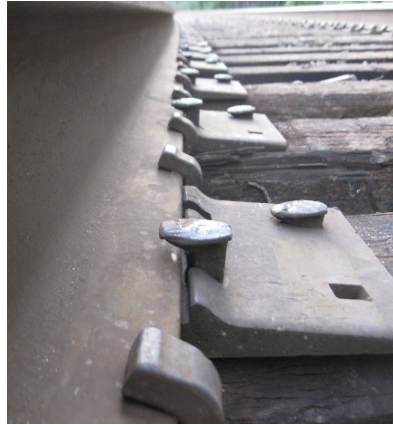
Station 14

The low rail showed additional evidence of dynamic cant from beginning of the curve to the POD.

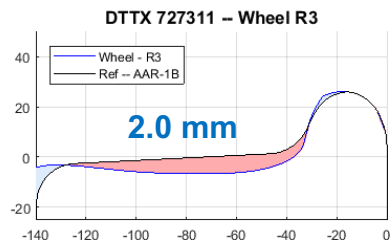
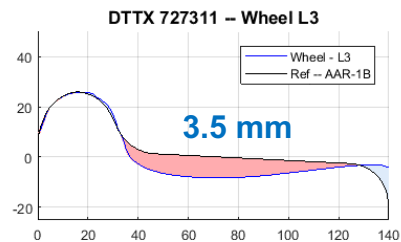
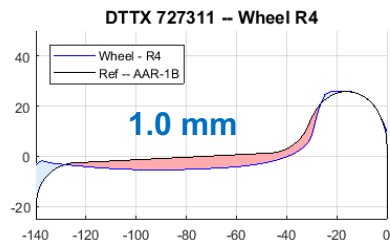
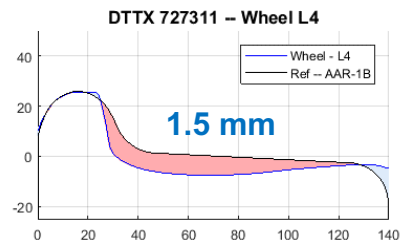
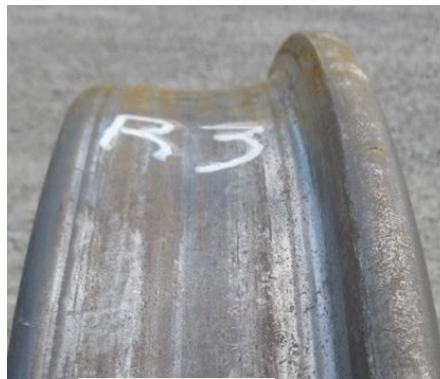
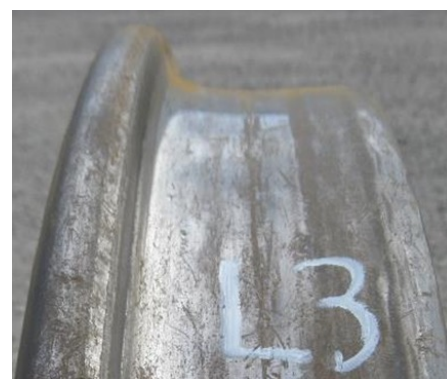
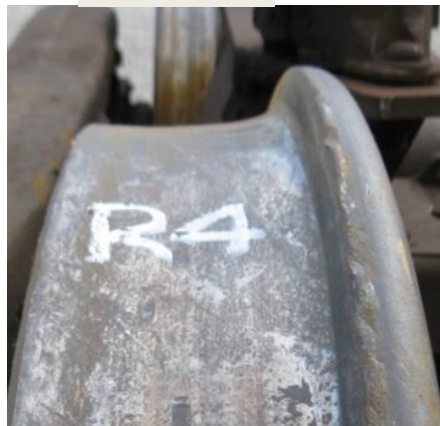
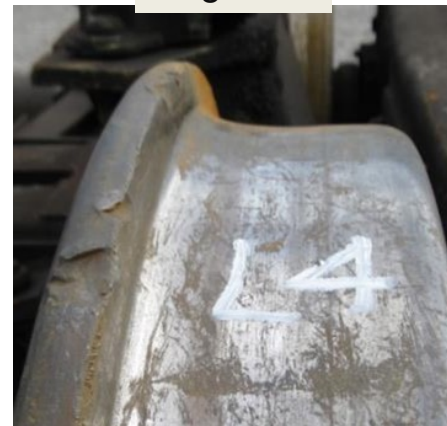
WHEEL PROFILES C TRUCK

Note asymmetric wear – each axle has a wheel with a worn flange and hollow tread, and a wheel with a full flange and normal tread.

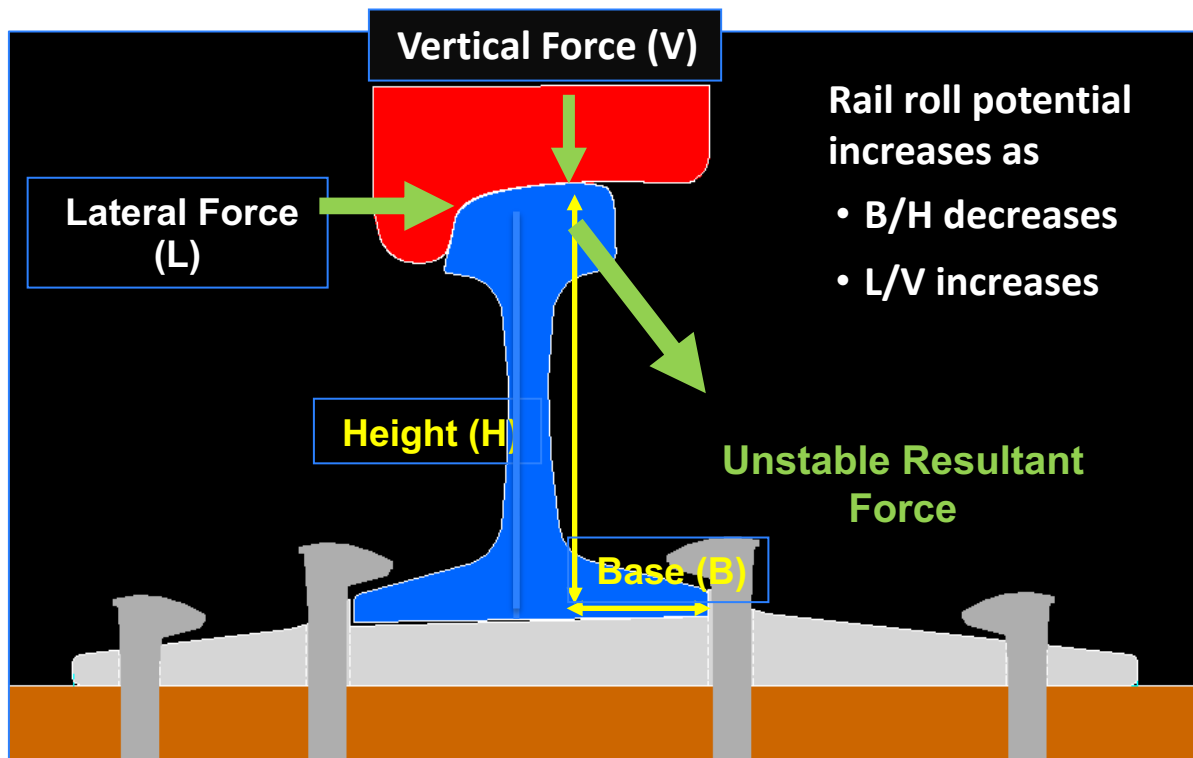
Vertical force shifted toward the field side +

increased lateral force due to poor truck steering.....

produce a resultant directed outside the rail base.

This is an unstable condition - an unrestrained rail will tend to roll outward.

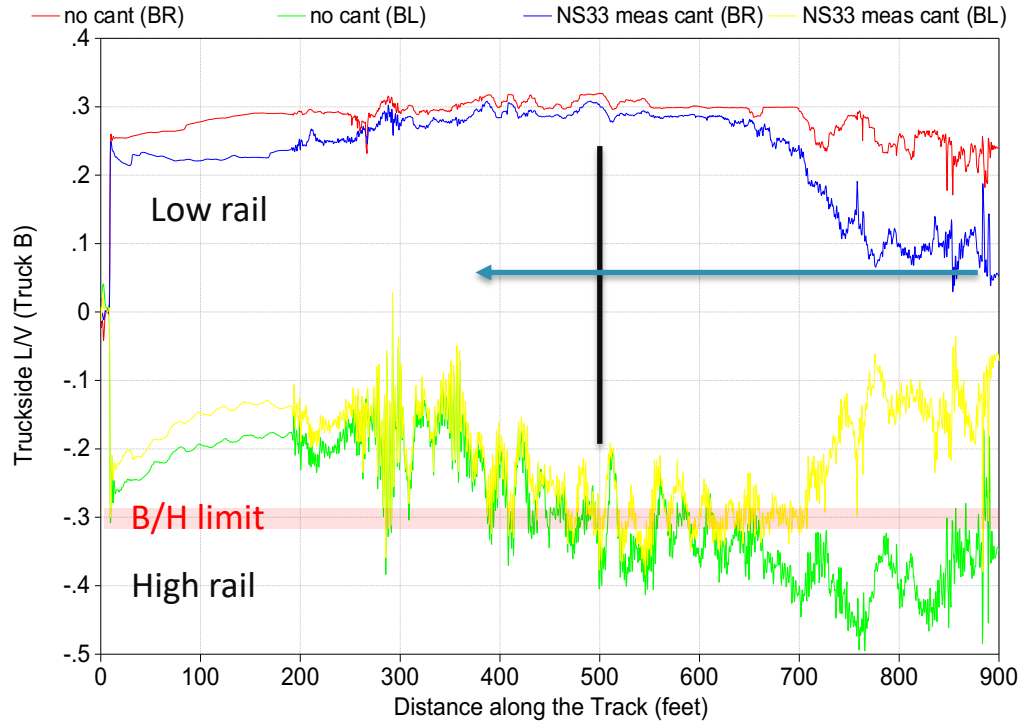
VAMPIRE TRUCKSIDE L/V RATIOS FOR B TRUCK

How do we know?
Minimal damage to the B truck wheels

There would likely be no derailment if B truck were the only consideration.

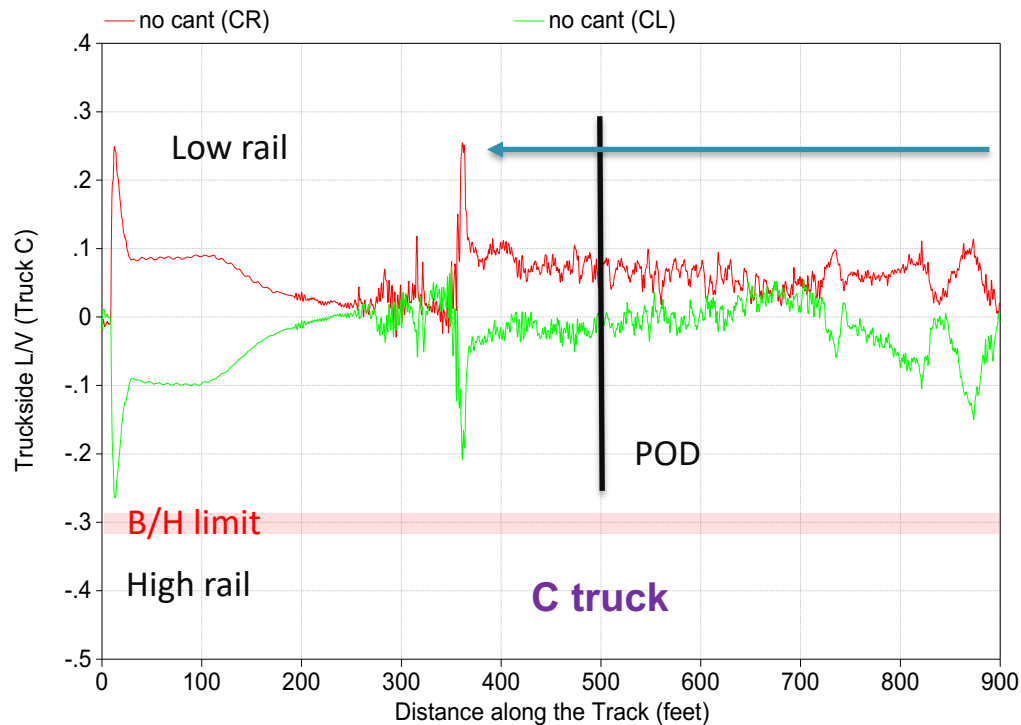
VAMPIRE TRUCKSIDE L/V RATIOS FOR C TRUCK

Based on the truckside L/V ratios predicted by VAMPIRE, and the fact that the worn wheel profile had a greater impact than the worn rail profile:

“High rail rolled out under lead and intermediate trucks of loaded articulated doublestack DTTX 727311 account significantly hollow (but non-defective) wheel profiles operating on a high rail in a 3.5° curve with moderate head slope and low B/H.”

FRA Cause Code: E65C Worn Tread

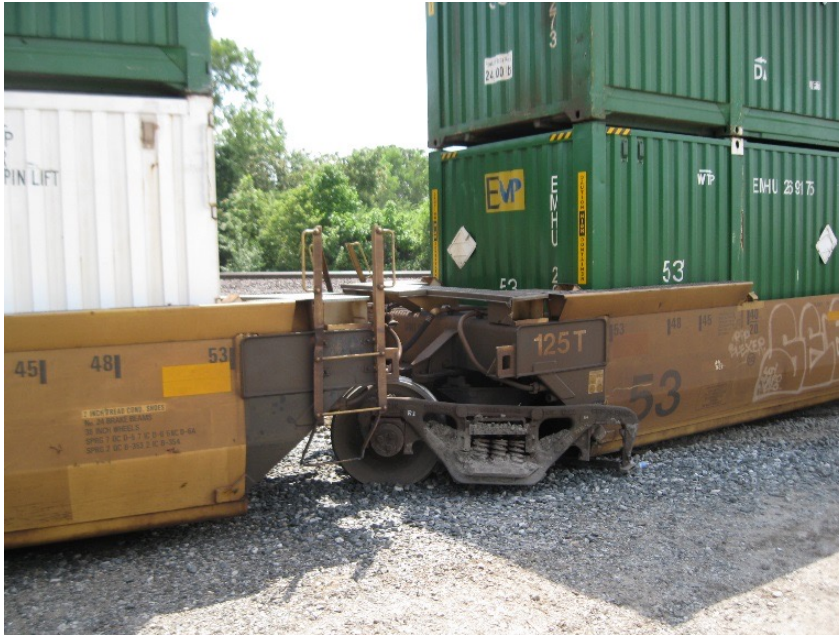
WHAT IS UNIQUE ABOUT MULTI-PLATFORM DOUBLESTACK CARS?

Elevated truckside L/V under an articulated intermediate truck are particularly dangerous because.....

there is no adjacent truck applying a vertical load to hold down the rail.
